**Flood Control Project Maintenance  
Levee Inspections**

## Maintenance Issue Types Only, Levee Inspection Report By Mile - Spring 2015

### Reclamation District No. 0556 Upper Andrus

Waterway	Bank	Unit Miles	Inspection Start/End	Inspector
Unit No. 01 Georgiana Slough	Right	5.48	04/29/2015 04/29/2015	Herman Phillips

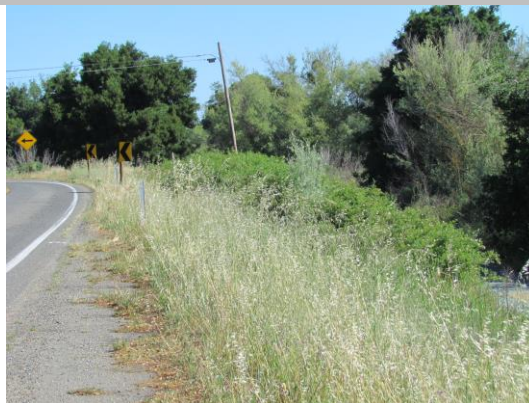
Photo 1 of 1 : SP\_2015\_RD0556\_18\_72\_20150430\_00023.jpg

LM Start	0.08	Rating **	U	Issue No.	72
LM End	0.22	Issue Type +	Ma	Location *	WS
Category	Earthen Levee			GPS Latitude/Longitude	
				Start	End
Item	Vegetation			38.237925 °	38.236055 °
				-121.518200 °	-121.518040 °
DWR ID	DWR_RD0556_01_s_2015_72				
Action/Comments					
Remove the wild growth other than native grasses from the levee slopes.					
Inspector Comments: Remove the unacceptable wild growth.

RD 556 Unit 1 looking back upstream wild roses and other tall weeds on the levee slope.

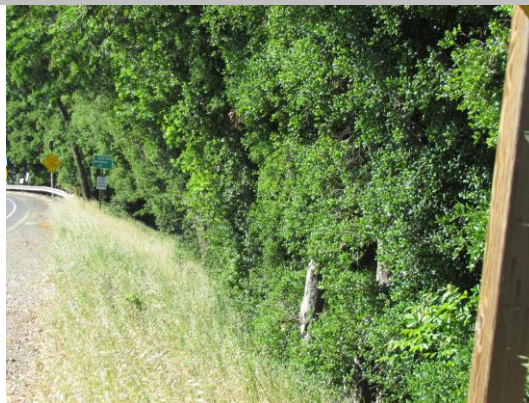
Photo 1 of 1 : SP\_2015\_RD0556\_18\_26\_20150430\_00025.jpg

LM Start	0.22	Rating **	U	Issue No.	26
LM End	1.70	Issue Type +	Ma	Location *	LS
Category	Earthen Levee			GPS Latitude/Longitude	
				Start	End
Item	Vegetation			38.236055 °	38.224305 °
				-121.518035 °	-121.537263 °
DWR ID	DWR_RD0556_01_f_2014_26				
Action/Comments					
Trees / Woody Vegetation					
Inspector Comments: The woody tree growth blocks view of the levee slope.

Woody tree growth on the landward levee slope.

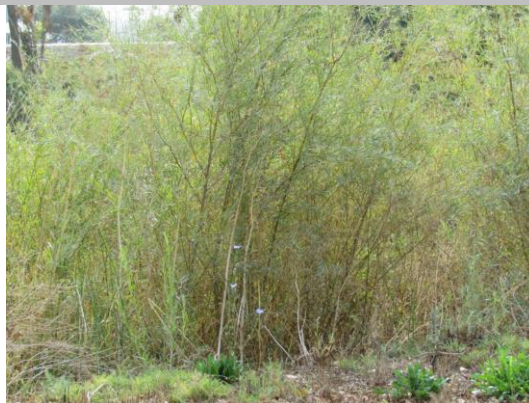
Photo 1 of 1 : SP\_2015\_RD0556\_18\_30\_20150312\_00009.jpg

LM Start	0.27	Rating **	U	Issue No.	30
LM End	0.61	Issue Type +	Ma	Location *	WS
Category	Earthen Levee			GPS Latitude/Longitude	
				Start	End
Item	Vegetation			38.235427 °	38.231538 °
				-121.518523 °	-121.522553 °
DWR ID	DWR_RD0556_01_f_2014_30				
Action/Comments					
Trees / Woody Vegetation					
Inspector Comments: Remove the young willow trees from waterside slope.

Unacceptable wild tree growth on the waterside slope.

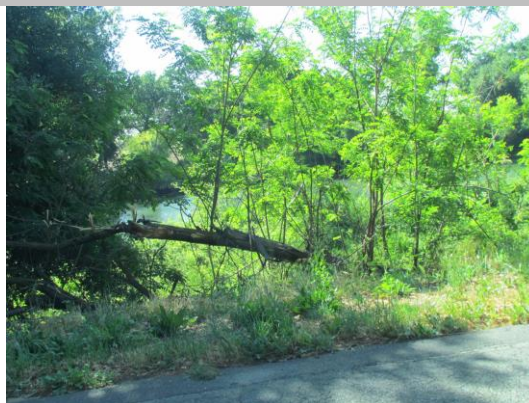
Photo 1 of 1 : SP\_2015\_RD0556\_18\_61\_20150430\_00027.jpg

LM Start	0.42	Rating **	U	Issue No.	61
LM End	0.42	Issue Type +	Ma	Location *	WS
Category	Earthen Levee			GPS Latitude/Longitude	
				Start	End
Item	Encroachments			38.233775 °	38.233775 °
				-121.520351 °	-121.520351 °
DWR ID	DWR_RD0556_01_f_2012_61				
Action/Comments					
Tree or limb					
Inspector Comments: There is a dead tree at this location. Remove it from the levee section. The district is aware of this issue.

This fallen tree hasn't been removed from levee section waterward.

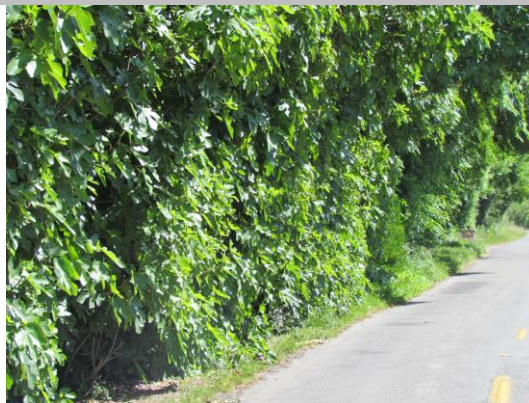
Photo 1 of 1 : SP\_2015\_RD0556\_18\_376\_20150430\_00028.jpg

LM Start	0.62	Rating **	U	Issue No.	376
LM End	0.90	Issue Type +	Ma	Location *	LS
Category	Earthen Levee			GPS Latitude/Longitude	
				Start	End
Item	Vegetation			38.231535 °	38.228602 °
				-121.522675 °	-121.526289 °
DWR ID	DWR_RD0556_01_s_2014_376				
Action/Comments					
Trees / Woody Vegetation					
Inspector Comments: District should remove these unacceptable fig trees from the landside levee section.

Remove the fig trees on the landside shoulder and toe.

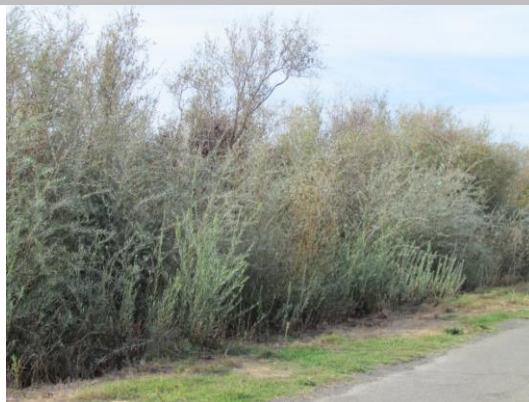
Photo 1 of 1 : SP\_2015\_RD0556\_18\_49\_20150312\_00011.jpg

LM Start	1.75	Rating **	U	Issue No.	49
LM End	1.99	Issue Type +	Ma	Location *	WS
Category	Earthen Levee			GPS Latitude/Longitude	
				Start	End
Item	Vegetation			38.224120 °	38.223590 °
				-121.538137 °	-121.542387 °
DWR ID	DWR_RD0556_01_f _ 2014_49				
Action/Comments					
Trees / Woody Vegetation					
Inspector Comments: Remove the unacceptable tree growth from the levee section on the waterward side.

Woody tree growth blocks view of the waterward slope.

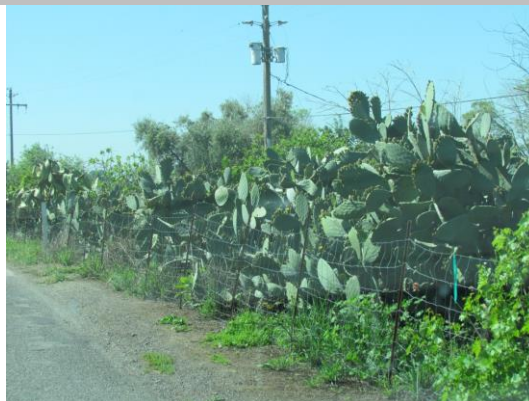
Photo 1 of 1 : SP\_2015\_RD0556\_18\_395\_20150312\_00022.jpg

LM Start	3.26	Rating **	M	Issue No.	395
LM End	3.37	Issue Type +	Ma	Location *	LS
Category	Earthen Levee			GPS Latitude/Longitude	
				Start	End
Item	Vegetation			38.210185 °	38.208899 °
				-121.540264 °	-121.541340 °
DWR ID	DWR_RD0556_01_f_2013_395				
Action/Comments					
Remove the wild growth other than native grasses from the levee slopes.					
Inspector Comments: This wild growth is unacceptable and blocking visibility and access.

Unacceptable wild growth of cactus completely blocking visibility of the entire levee section.

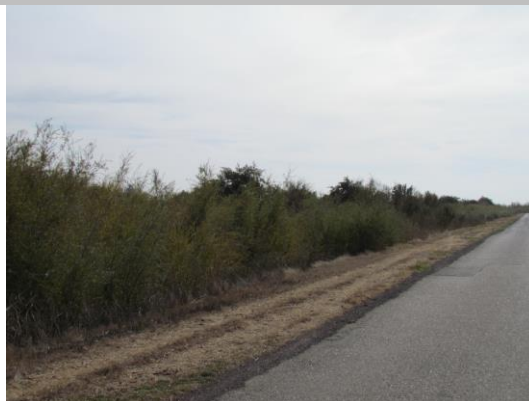
Photo 1 of 1 : SP\_2015\_RD0556\_18\_68\_20150312\_00016.jpg

LM Start	3.59	Rating **	U	Issue No.	68
LM End	3.85	Issue Type +	Ma	Location *	WS
Category	Earthen Levee			GPS Latitude/Longitude	
				Start	End
Item	Vegetation			38.205630 °	38.202080 °
				-121.541647 °	-121.541003 °
DWR ID	DWR_RD0556_01_f_2014_68				
Action/Comments					
Trees / Woody Vegetation					
Inspector Comments: Control the vegetation on the waterside levee section.

Unacceptable woody tree growth on the waterside slope and toe.

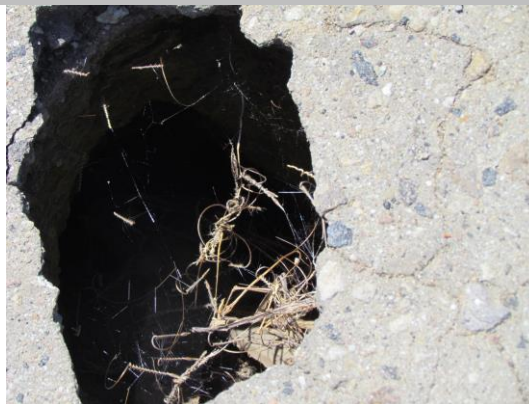
Photo 1 of 1 : SP\_2015\_RD0556\_18\_69\_20150430\_00035.jpg

LM Start	4.05	Rating **	U	Issue No.	69
LM End	4.05	Issue Type +	Ma	Location *	LS
Category	Earthen Levee			GPS Latitude/Longitude	
				Start	End
Item	Animal Control			38.995700 °	38.995700 °
				-120.346300 °	-120.346300 °
DWR ID	DWR_RD0556_01_s_2015_69				
Action/Comments					
No rodents visible, but rodent burrows visible; need to backfill and compact or grout burrows.					
Inspector Comments: There is a rodent hole in crown roadway more than 3-foot deep. The RD need to correct this issue.

This rodent hole is in the levee crown roadway and goes down some 3-4 foot deep. Repairs are needed.

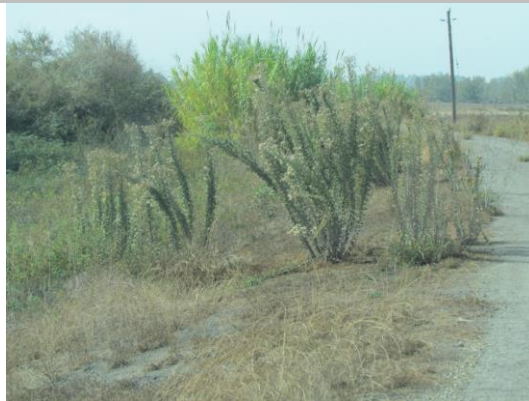
Photo 1 of 1 : SP\_2015\_RD0556\_18\_67\_20150312\_00015.jpg

LM Start	4.07	Rating **	U	Issue No.	67
LM End	5.48	Issue Type +	Ma	Location *	WS
Category	Earthen Levee			GPS Latitude/Longitude	
				Start	End
Item	Vegetation			38.200658 °	38.186464 °
				-121.544711 °	-121.562550 °
DWR ID	DWR_RD0556_01_s _ 2013_67				
Action/Comments					
Remove the wild growth other than native grasses from the levee slopes.					
Inspector Comments: Remove the wild weed growth and arundo from the waterside levee section.

Unacceptable tall weeds along with arundo present on the waterside slope.

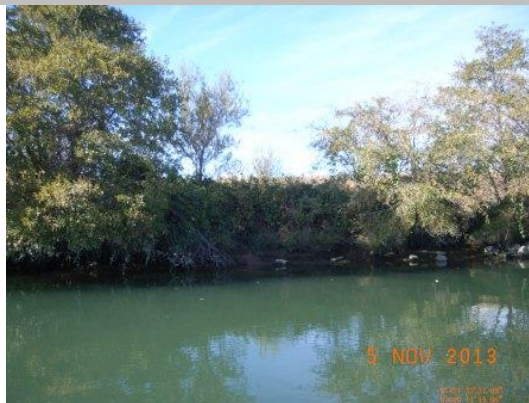
Photo 1 of 1 : SP\_2015\_RD0556\_18\_16\_20150312\_00004.jpg

LM Start	5.12	Rating **	M	Issue No.	16
LM End	5.29	Issue Type +	Ma	Location *	WS
Category	Supplemental			GPS Latitude/Longitude	
				Start	End
Item	USACE Erosion Survey			38.189775 °	38.187967 °
				-121.557729 °	-121.559572 °
DWR ID	DWR_RD0556_01_f_2014_16				
Action/Comments					
Inspector Comments: 1997 - Toe damaged rock. 1999 - One pocket filled with gravel. 2000 - Eroding beach with some biotech rolls and stakes; some gravel on slope. 2001 - Staked, low fascine walls at bankline. 2005 - Stone revetment in between pockets. 2006 - New rock on upper slope behind brush boxes at the upstream end, Stone is sliding off the hard toe. 2013: No observed changes. [2013 Site ID: GEO_7-0_R]

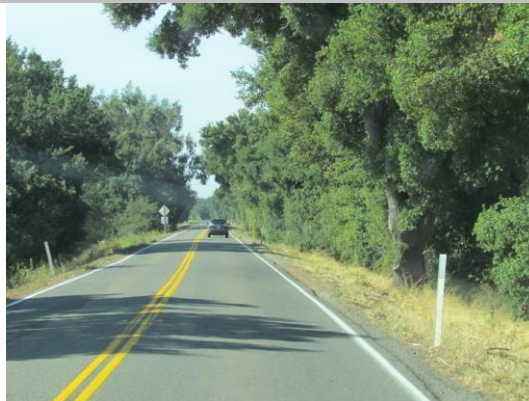
Photo 1 of 1 : SP\_2015\_RD0556\_19\_82\_20150312\_00016.jpg

LM Start	0.00	Rating **	U	Issue No.	82
LM End	0.00	Issue Type +	Ma	Location *	WS
Category	Earthen Levee			GPS Latitude/Longitude	
				Start	End
Item	Vegetation			38.200550 °	38.200550 °
				-121.544190 °	-121.544190 °
DWR ID	DWR_RD0556_02_s_2013_82				
Action/Comments					
Remove the wild growth other than native grasses from the levee slopes.					
Inspector Comments: Both slopes downstream covered with wild growth.

Looking downstream waterside slope overgrown.

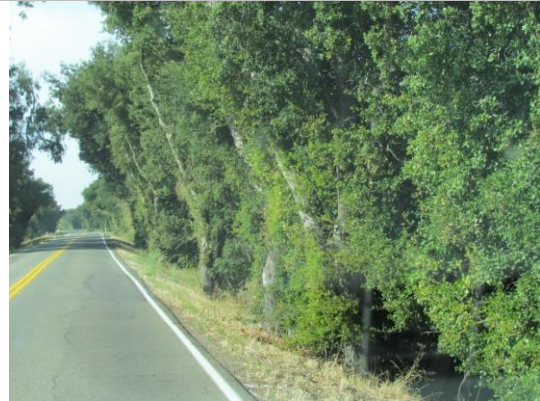
Photo 1 of 1 : SP\_2015\_RD0556\_19\_32\_20150312\_00011.jpg

LM Start	0.12	Rating **	U	Issue No.	32
LM End	2.87	Issue Type +	Ma	Location *	WS
Category	Earthen Levee			GPS Latitude/Longitude	
				Start	End
Item	Trim / Thin Trees			38.238939 °	38.229108 °
				-121.520360 °	-121.555298 °
DWR ID	DWR_RD0556_02_f_2014_32				
Action/Comments					
Thin trees to allow visibility of the ground and room to flood fight. Inspector Comments: The trees should be trimmed up to allow the ground to be seen.

Woody tree growth on the waterside levee section.

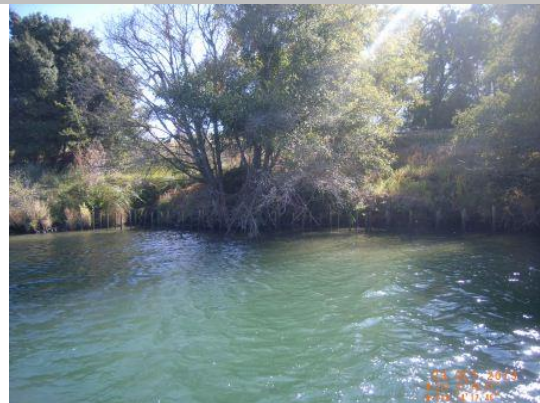
Photo 1 of 1 : SP\_2015\_RD0556\_19\_28\_20150312\_00010.jpg

LM Start	0.31	Rating **	M	Issue No.	28
LM End	0.60	Issue Type +	Ma	Location *	WS
Category	Supplemental			GPS Latitude/Longitude	
				Start	End
Item	USACE Erosion Survey			38.238784 °	38.237862 °
				-121.523932 °	-121.529188 °
DWR ID	DWR_RD0556_02_f_2014_28				
Action/Comments					
Inspector Comments: 2002 - Two rocked sections (150 ft long) at the downstream end. 2005 - Lots of old brush boxes, some with established vegetation in the area behind the boxes. 2006 - Some small spots fixed with stone. 2009 - Minimal new erosion, rock in the middle of the reach may be new. 2011 - Minor new erosion at the toe. 2013: Minor new erosion. [2013 Site ID: SAC_26-0_L]

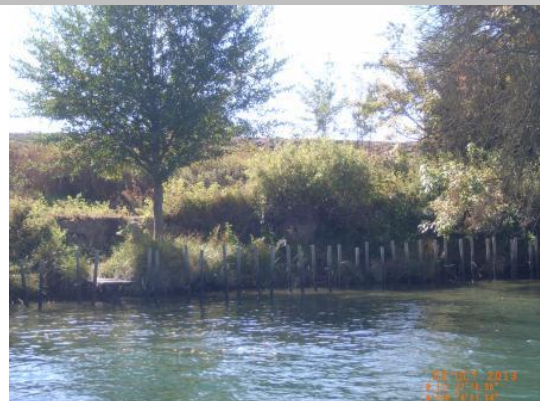
Photo 1 of 1 : SP\_2015\_RD0556\_19\_27\_20150312\_00009.jpg

LM Start	1.03	Rating **	M	Issue No.	27
LM End	1.15	Issue Type +	Ma	Location *	WS
Category	Supplemental			GPS Latitude/Longitude	
				Start	End
Item	USACE Erosion Survey			38.238772 °	38.239265 °
				-121.536788 °	-121.538845 °
DWR ID	DWR_RD0556_02_f_2014_27				
Action/Comments					
Inspector Comments: 1997 - Rock is in poor condition and has failed in many places.  Scallops in berm with remnants of old rock in the toe area.  2005 - Brush boxes present. 2013: Site extended upstream approximately 300 ft to include new erosion pockets. [2013 Site ID: SAC_25-2_L]

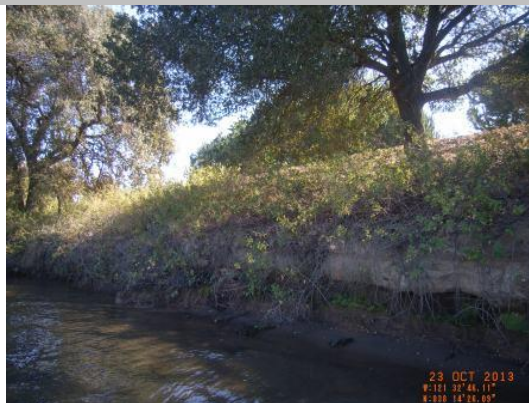
Photo 1 of 1 : SP\_2015\_RD0556\_19\_26\_20150312\_00008.jpg

LM Start	1.45	Rating **	M	Issue No.	26
LM End	1.59	Issue Type +	Ma	Location *	WS
Category	Supplemental			GPS Latitude/Longitude	
				Start	End
Item	USACE Erosion Survey			38.240401 °	38.240772 °
				-121.544106 °	-121.546791 °
DWR ID	DWR_RD0556_02_f_2014_26				
Action/Comments					
Inspector Comments: 1997 - Slow erosion of the berm at the waterline; bench below water. 2005 - Brush boxes present. 2010 - Minor new erosion. 2013: There is little to no berm remaining at downstream end of this site. [2013 Site ID: SAC_24-8_L]

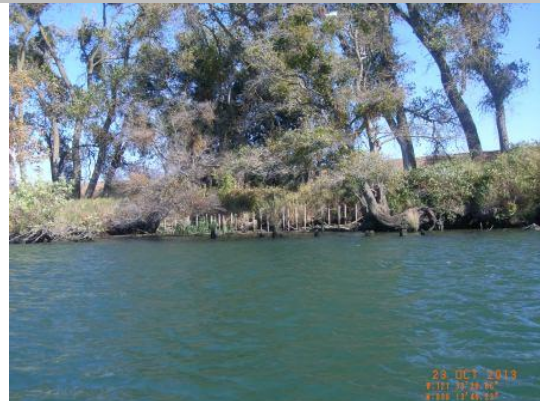
Photo 1 of 1 : SP\_2015\_RD0556\_19\_25\_20150312\_00007.jpg

LM Start	2.93	Rating **	M	Issue No.	25
LM End	3.04	Issue Type +	Ma	Location *	WS
Category	Supplemental			GPS Latitude/Longitude	
				Start	End
Item	USACE Erosion Survey			38.228202 °	38.226601 °
				-121.555502 °	-121.555605 °
DWR ID	DWR_RD0556_02_f_2014_25				
Action/Comments					
Inspector Comments: 1997 - Few scallops in berm, some getting close to levee toe. 2005 - Brush boxes present. 2012 - More erosion of the toe since last year. 2013: No observed changes. [2013 Site ID: SAC_23-3_L]

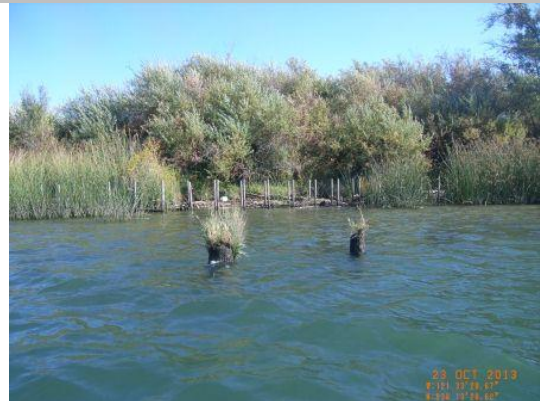
Photo 1 of 1 : SP\_2015\_RD0556\_19\_23\_20150312\_00005.jpg

LM Start	3.16	Rating **	M	Issue No.	23
LM End	3.28	Issue Type +	Ma	Location *	WS
Category	Supplemental			GPS Latitude/Longitude	
				Start	End
Item	USACE Erosion Survey			38.224850 °	38.223233 °
				-121.555641 °	-121.555687 °
DWR ID	DWR_RD0556_02_f_2014_23				
Action/Comments					
Inspector Comments: 2000 - Recently fallen cottonwood at the downstream end. 2005 - Empty brush boxes. 2011 - A few trees have fallen since last year. 2012 - Potential new tree popout since last year. 2013: New erosion at downstream end of site and a recent tree pop-out observed. [2013 Site ID: SAC_23-2_L]

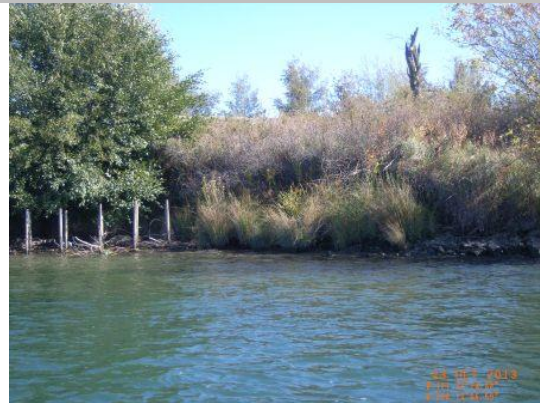
Photo 1 of 1 : SP\_2015\_RD0556\_19\_22\_20150312\_00004.jpg

LM Start	3.58	Rating **	M	Issue No.	22
LM End	3.64	Issue Type +	Ma	Location *	WS
Category	Supplemental			GPS Latitude/Longitude	
				Start	End
Item	USACE Erosion Survey			38.218951 °	38.218104 °
				-121.556689 °	-121.556819 °
DWR ID	DWR_RD0556_02_f_2014_22				
Action/Comments					
Inspector Comments: 1997 - Scallops into berm and very close to levee toe. 2005 - Brush boxes present. 2011 - New toe scour and freshly fallen tree. 2012 - New tree popout has taken significant portion of soil out of the levee. 2013: No observed changes. [2013 Site ID: SAC_22-7_L]

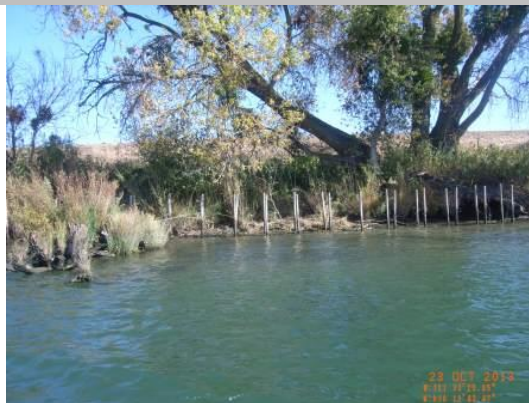
Photo 1 of 1 : SP\_2015\_RD0556\_19\_21\_20150312\_00003.jpg

LM Start	3.95	Rating **	M	Issue No.	21
LM End	4.12	Issue Type +	Ma	Location *	WS
Category	Supplemental			GPS Latitude/Longitude	
				Start	End
Item	USACE Erosion Survey			38.213581 °	38.211112 °
				-121.557197 °	-121.557042 °
DWR ID	DWR_RD0556_02_f_2014_21				
Action/Comments					
Inspector Comments: 2002 - Spot rock along berm, but not in the erosion pockets. 2005 - Some new minor stone revetment at the upstream end. Brush boxes present. 2006 - Currently installing new brush in downstream brush boxes. 2007 - Rock in middle portion for about 150 ft. 2010 - Some attempt at repairs but still has pockets of erosion. 2012 - More erosion along the toe. 2013: No observed changes. [2013 Site ID: SAC_22-5_L]

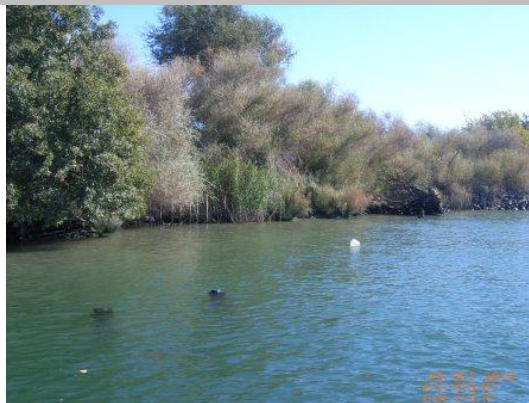
Photo 1 of 1 : SP\_2015\_RD0556\_19\_19\_20150312\_00002.jpg

LM Start	4.44	Rating **	M	Issue No.	19
LM End	4.49	Issue Type +	Ma	Location *	WS
Category	Supplemental			GPS Latitude/Longitude	
				Start	End
Item	USACE Erosion Survey			38.206379 °	38.205733 °
				-121.557089 °	-121.556999 °
DWR ID	DWR_RD0556_02_f_2014_19				
Action/Comments					
Inspector Comments: 2013: Erosion pockets encroaching on levee foundation. [2013 Site ID: SAC_21-9_L]

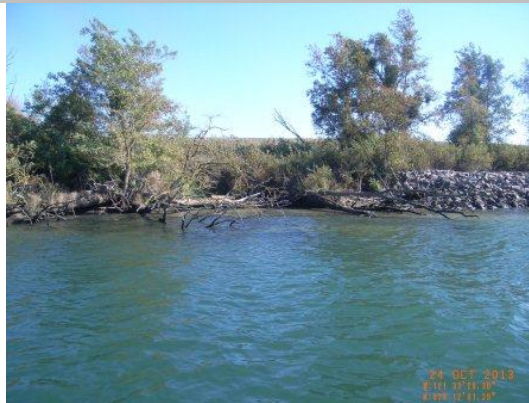
Photo 1 of 1 : SP\_2015\_RD0556\_19\_3\_20150312\_00001.jpg

LM Start	4.85	Rating **	M	Issue No.	3
LM End	4.88	Issue Type +	Ma	Location *	WS
Category	Supplemental			GPS Latitude/Longitude	
				Start	End
Item	USACE Erosion Survey			38.200646 °	38.200225 °
				-121.557606 °	-121.557749 °
DWR ID	DWR_RD0556_02_f_2014_3				
Action/Comments					
Inspector Comments: 1999 - Downstream 140 ft repaired with rock. 2010 - Lots of woody debris, but no changes to site. 2013: No observed changes. [2013 Site ID: SAC_21-5_L]
